# Hardening the Mountain High O2D1 against False triggering

C. Zavatson

11-14-2019

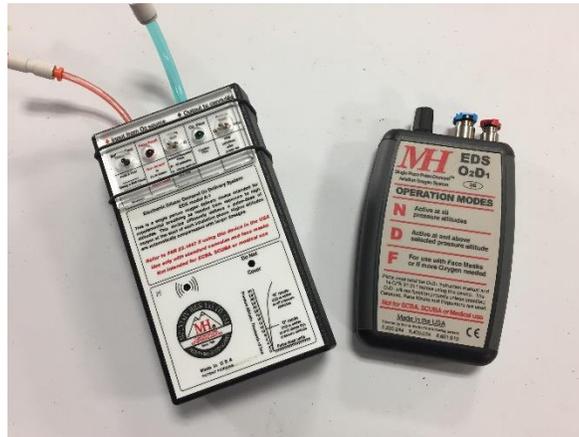
The latest version of the Mountain High pulse demand O2D1 controller has been susceptible to EMI providing false triggers and oxygen delivery. This is unique to the latest version, a compact SMT design. The older analog units did not exhibit this sensitivity.

Figure 1, Mountain High EDS units, original A-1 vs latest O2D1

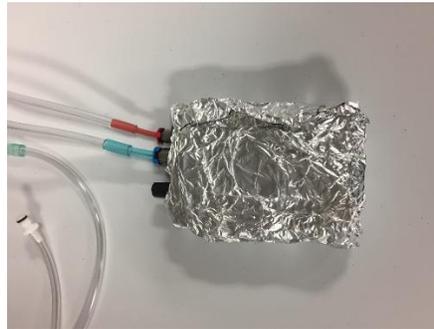
In order to both verify the EMI theory and begin work on a solution, I wrapped the unit in aluminum foil. While airborne the EDS unit was flawless. When I removed the aluminum wrap, the false triggering started up. Again wrapping the EDS unit in aluminum foil stopped all misbehavior. This confirmed that the false triggering was indeed related to EMI.

*Figure 3, EDS O2D1 wrapped in aluminum foil as an EMI shield*

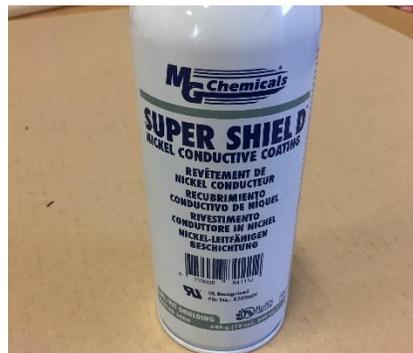
*Figure 4, MG Super Shield Conductive Coating*

The final solution needed to be more aesthetically pleasing than aluminum foil wrapped around the exterior. I coated the interior of the plastic enclosure with a spray-on nickel based EMI shield. While not as opaque as a full wrap of aluminum foil, it was sufficient to shield the EDS electronics.

This spray on EMI shield is specifically designed for adhering to plastic. Some areas need to be masked off include where the battery terminals clip on and the studs that mount the PCB. As an extra precaution, electrical tape was added where energized metallic components, battery terminals for

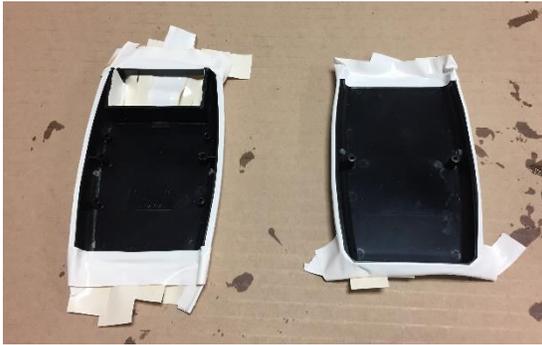
*Figure 5, Masked Enclosure*

example, were in close proximity to the case and could potentially make contact if they moved or slid out of position.

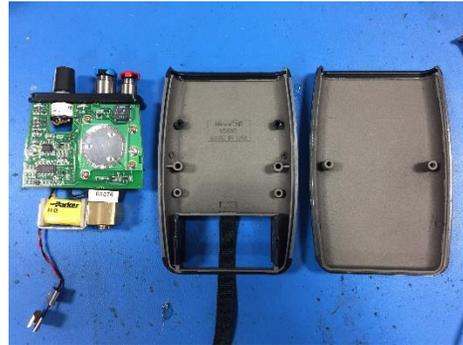
*Figure 6, Coated Enclosure ready for reassembly*

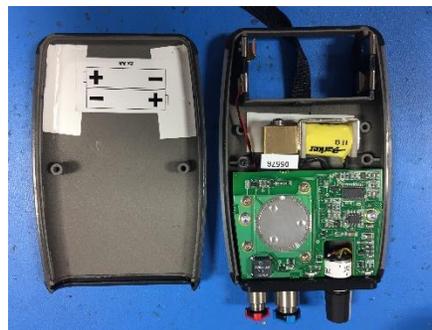
*Figure 7, EDS unit partially reassembled*

This has resolved the false triggering that had been taking a toll on oxygen range over the last two years. Somewhere in the evolution from analog to low voltage digital, a sensitivity to radiated 1090MHz emissions was introduced.
