Lancair 320/360 Small (Original) Tail Trim Tab Modification

C. Zavatson, 1/23/2015

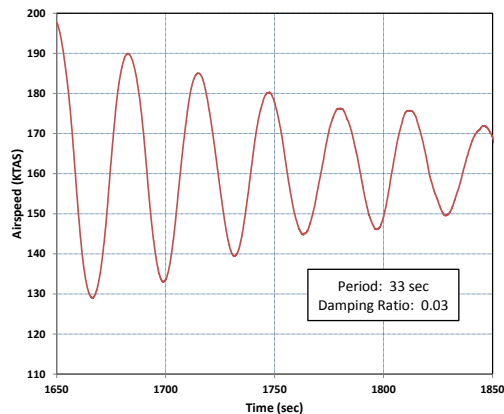
One of the drawback of this type of system is that it adds a degree of pitch instability to the aircraft. This is caused by the decoupling of the trim input from airspeed. Hinge moments on the tail are a function airspeed while the force imparted on the elevator by the spring is not. The plots below show this interaction in a simple phugoid maneuver. The phugoid is a gentle back and forth exchange of kinetic and potential energy. Figure 1 shows the phugoid with an original spring bias trim system. The period very short and the damping is minimal. Figure 2 shows a phugoid of an original small tail with the spring removed and a trim tab added. Note the lengthening of the period and the pronounced decay.

Figure 1, Original Tail, Spring Trim System

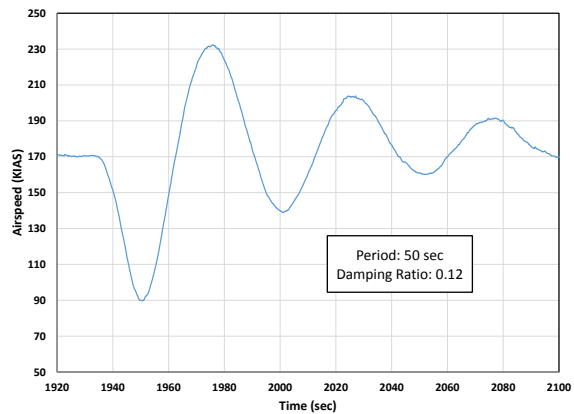
Figure 2, Original Tail, Trim Tab

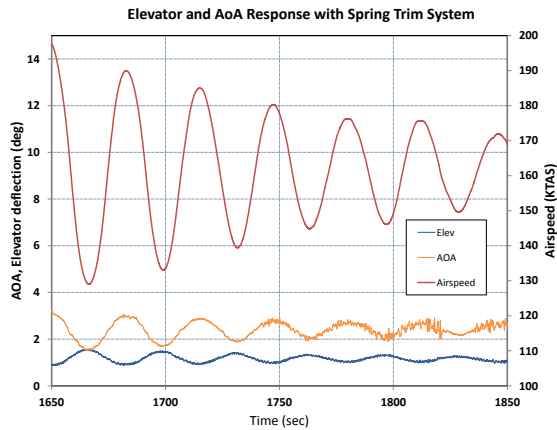
Figure 3 and Figure 4 provide more insight into the influence of the spring. These plots include angle of attack as well as elevator input. This maneuver is flown stick free, so the elevator is free to float. The spring bias trim system however imparts an elevator input as the hinge moment changes with airspeed. This alters the angle of attack throughout the maneuver and turns a benign gentle maneuver into a more aggressive one. The pull-outs generate significant G-loading. At the top of the maneuver the aircraft begins to approach zero g. Figure 4 shows a phugoid with a Mark II tail. Note how the elevator remains unaffected by the maneuver and the angle of attack has only a very slight variation. Note also that angle of attack changes in the opposite sense of the spring trim case.

Figure 3, Original Tail, Spring Trim System

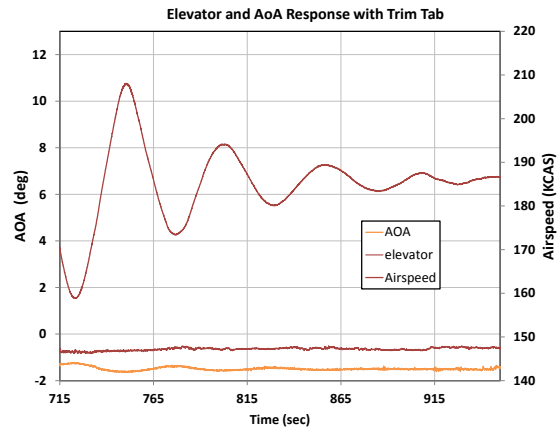
Figure 4, MKII Tail, Trim Tab

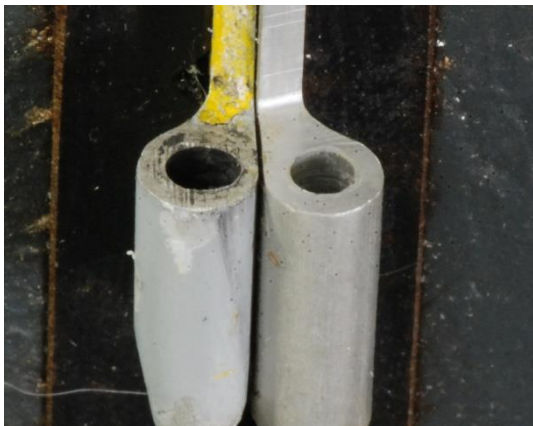
Before diving into the process of a modifying an elevator, a few words about the elevator hinges is warranted. The original tail uses standard MS hinges. Figure 5 shows the removed hinge on the left backed up to a piece of new hinge material. The wear is visible without even measuring. Wear is a common problem on these hinges in this application, in particular with the outboard hinges. Replacing the stock MS pin with a larger hinge pin will extend the life of the hinge. More information regarding hinge wear and corrective actions can be found in "[Hinge Play and Hinge Wear](#)". Even if not switching to a trim tab installation, these hinges should be checked and replaced if necessary.

Figure 5, Wear on removed hinge

Figure 5, Hinge wear on this particular outboard hinge was dangerously advanced. Nearly half the wall thickness had been eroded. The aircraft was white, but had been repainted. Note the yellow paint on

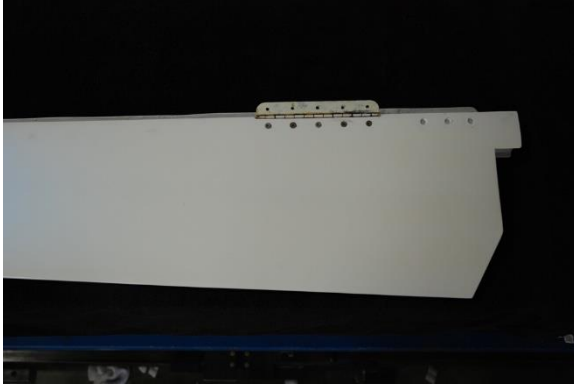
Figure 7, Original Elevator and Hinge

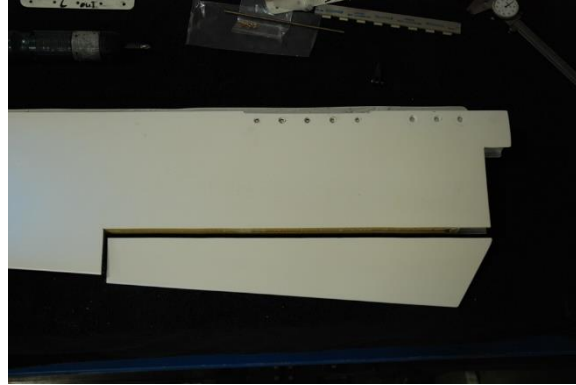
Figure 8, Trim Tab cut from Elevator

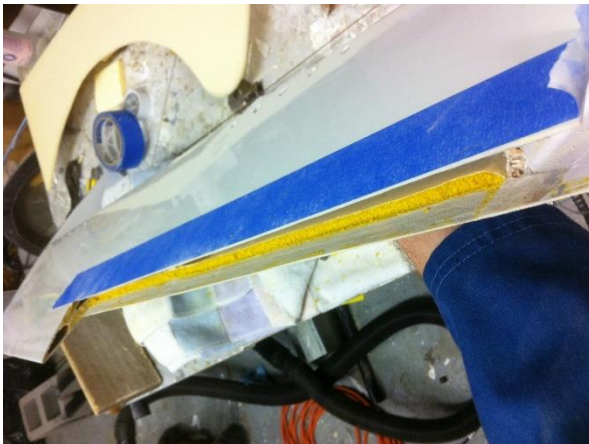
Figure 9, Core material removal

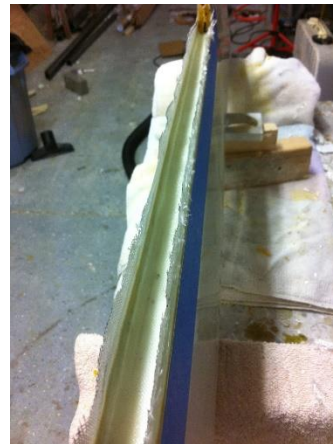
Figure 10, Rear Spar Close-out

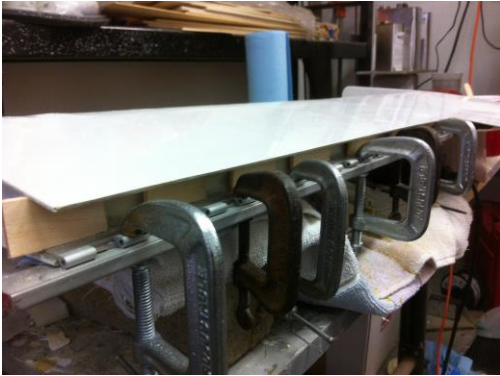
Figure 11, Elevator Hinge Mounting Surface Preparation

Hinges require a flat and straight mounting surface. $\frac{1}{4}$ " aluminum bars were used as backing while a flox release was done with the actual hinge sections.

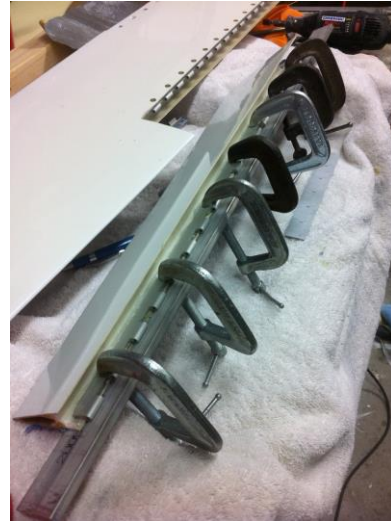
Figure 12, Tab Hinge Mounting Surface Preparation

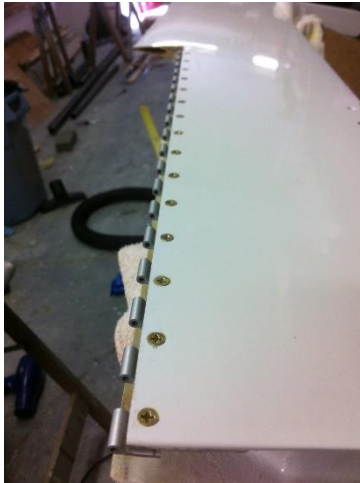
Figure 13, Hinge Installation

Both hinge halves were mounted with screws. This approach was the least disruptive to the finish of the parts. Alternatively the hinge sections could have been riveted. This would however require glass work and refinishing of the surfaces.

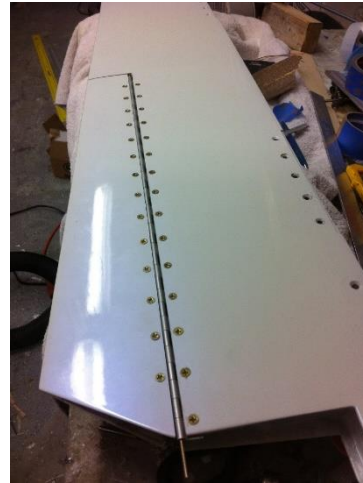
Figure 14, Trim Tab Trial Fit

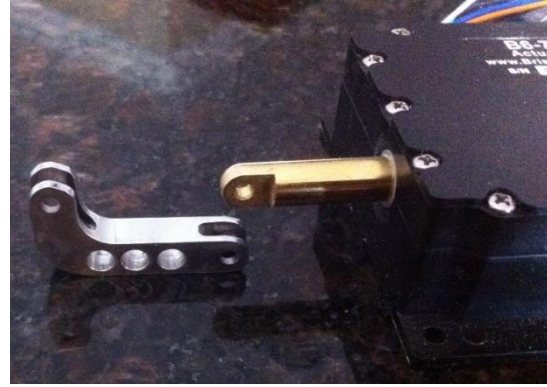
Figure 16, Actuator and Push Rod

Foam was used to shape the bottom of the tab so that it would provide a gap free movement. The foam received two layers of light weight fiber glass when done. The L-shaped push rod transfers servo motion to the tab without cutting through the lower skin of the elevator.

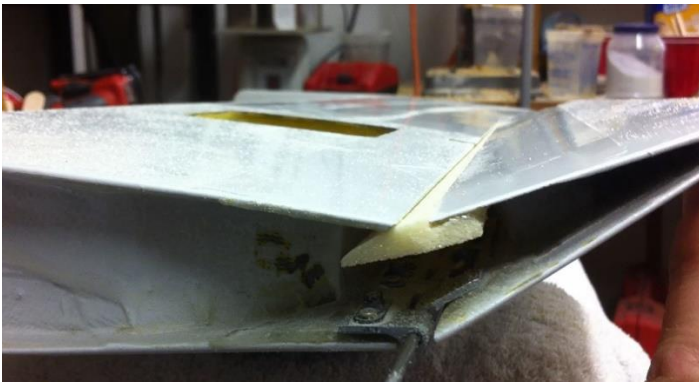
Figure 17, Contouring the Trim Tab

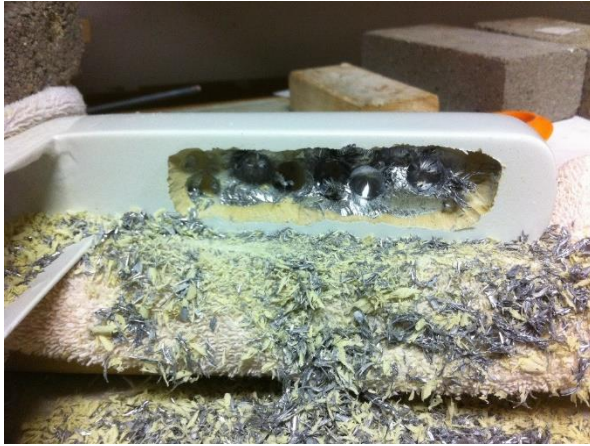
Figure 19, Lead Counter Weight Removal

The addition of the trim tab will require additional mass for balancing. The only practical way to achieve this is to remove some of the lead in the balance horn and replace it with Tungsten which has a much higher density. Most balance horns are filled with a combination of lead and epoxy. They typically are not solid lead. The packing density will determine how much material needs to be removed. Tungsten bucking bars are available in a variety of sizes and shapes. The most suitable size was selected to fit the volume. Lead was back-filled as needed. When balance was achieved, all weight was bonded and fiber glassed in to the horn. Micro was used to fill the remaining void.

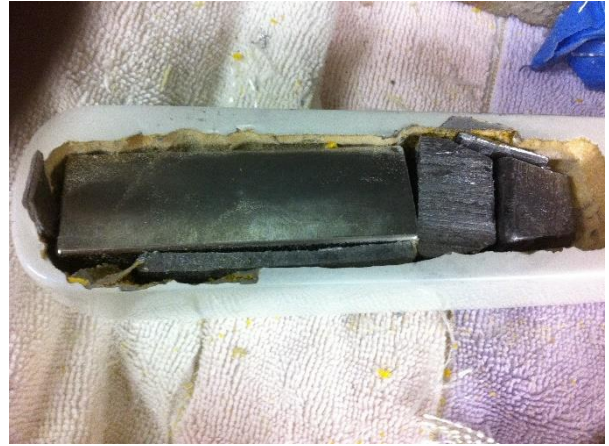
Figure 20, Tungsten Bar and Lead

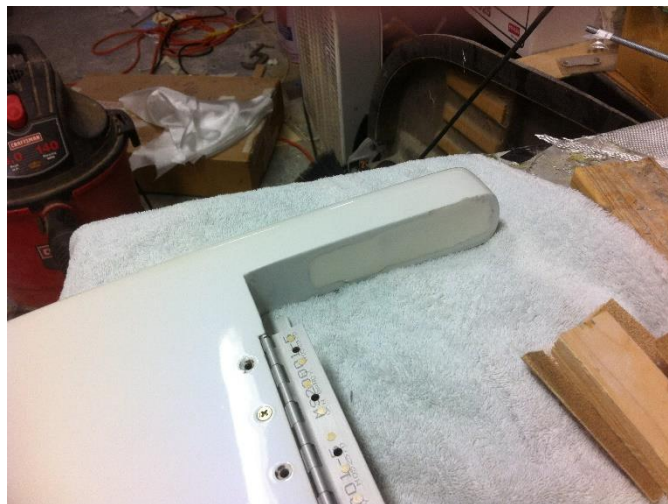
Figure 21, Micro Finish of Mass Balance Arm
