Rebuilding Lancair Hydraulic Cylinders

C. Zavatson, 7-1-2011

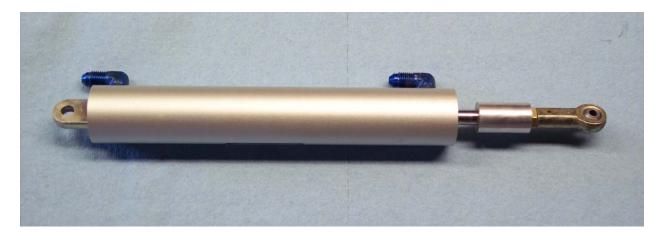
Here is the cylinder removed from the aircraft. The hydraulic fluid can be pumped out by moving the piston back and forth.

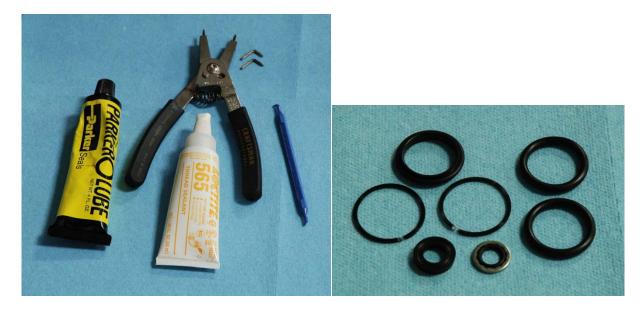
Above are some of the items you'll need: Parker O-Lube, Loctite 565 or equivalent, snap ring removal tool, seal pick and a set of new seals

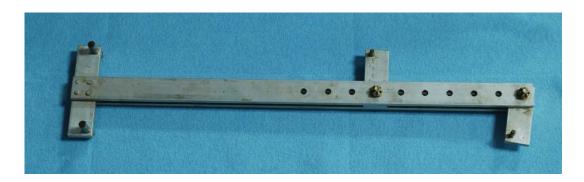
If a means of pressurizing the cylinder is available, the above device will precisely record the length of the cylinder in both the retracted and extended positions. After the cylinder is reassembled the rod end bearing is set to the recorded length. This eliminates the need to make adjustments on the plane. This only works if the cylinder is pressurized so that all slack is removed and the parts are loaded as when installed. Simply extending or compressing the cylinder by hand will not work.

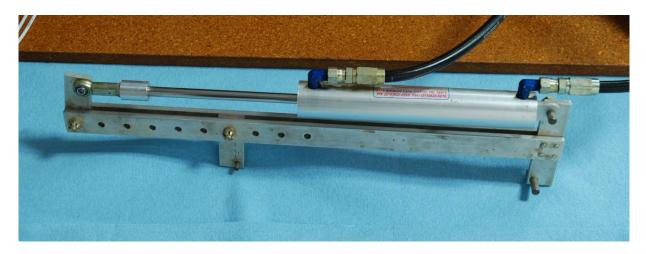
Here the extended length being captured. Tightening the bolt locks in the length.

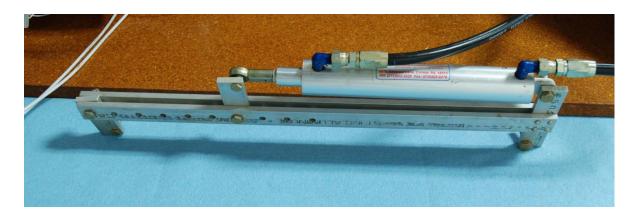
Now the retracted length being recorded.

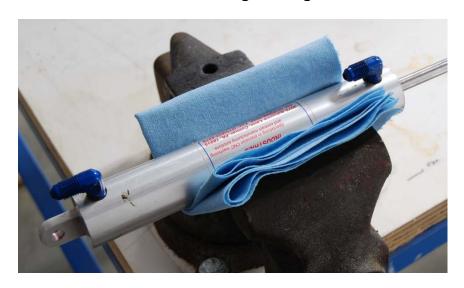
Pipe fittings are ready to be removed.

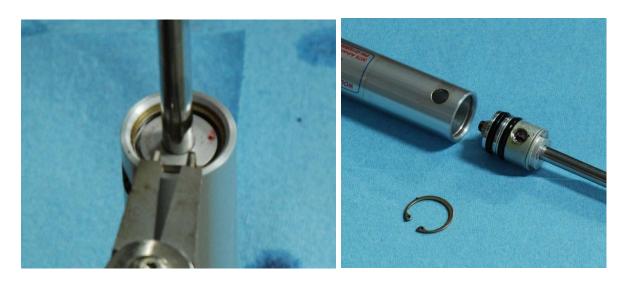
With the snap ring removed, pull out the piston assembly.

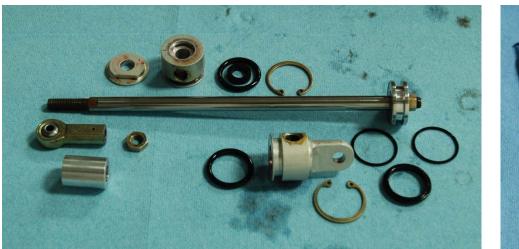
Us the same technique of pushing the end plug into the cylinder to remove the other side.

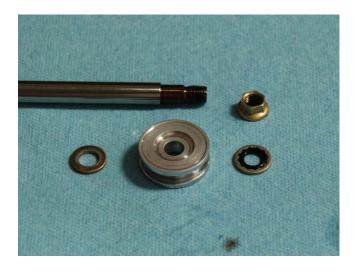
Now the piston can be removed. It contains the last seal, a sealing washer under the piston nut. The opposite end of the shaft has flats for clamping in a vise.

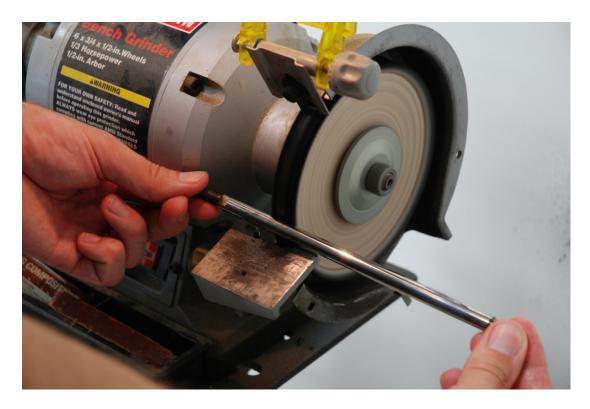
Most leaks are associated with some kind of surface damage to a sealing surface. These can be the direct source of the leak or they will have abraded the seal itself until it was unable to function properly. External leaks at the shaft seal are a good indication of a scratch on the shaft. Internal leaks are usually caused by damage to the cylinder bore, but may also originate at the piston sealing washer. Simply replacing seals when damage is present will lead to the leak returning. Surface damage needs to be removed to prevent the new seal from being damaged and suffering premature failure.

A buffing wheel and polishing compound will remove most scratches from the shaft. Deep scratches may require wet sanding prior to buffing.

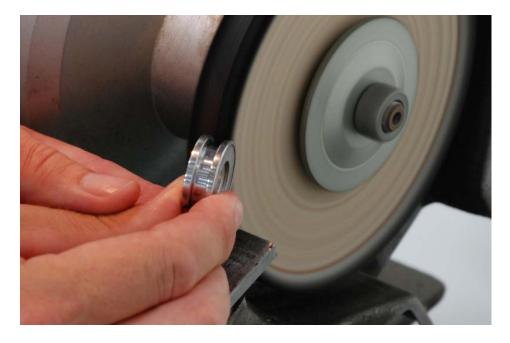
Every sealing surface should be inspected and polished to assure a good seal. The cylinder bore also needs to be carefully inspected. Looking through the bore at a well lit area will reveal scratches.

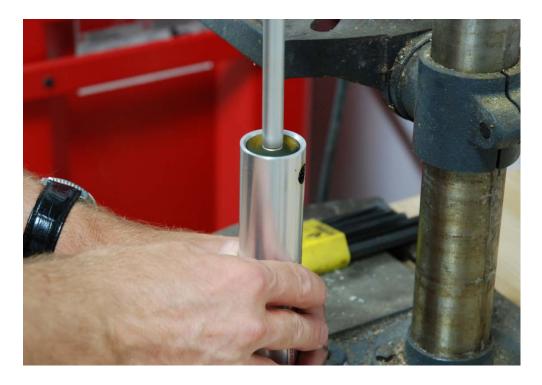
A drill press and WD40 as a cutting fluid work well to remove scratches and then polish the interior surface.

Home-made honing tools can be fabricated using sand paper of various grits ranges. 360 through 1,000 grit works well for both removing scratches and then polishing and honing. Initially cleaning the bore with a fine grit will make the deeper scratches quite visible. The desired surface finish for the cylinder is 5-20 micro-inches.

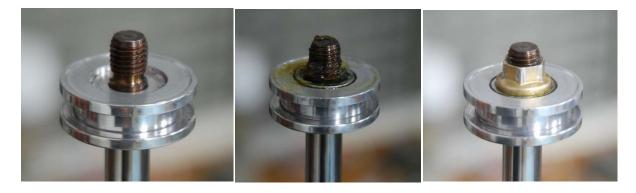
The sealing washer is installed with a generous amount of Parker O-Lube. This prevents damage during tightening of the nut.

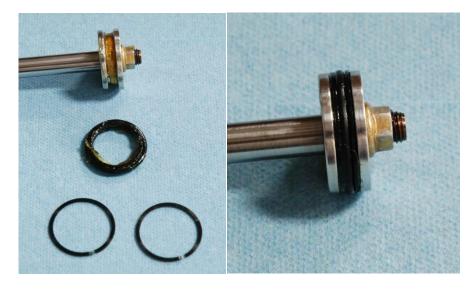
Parker O-Lube used on the piston seal during reassembly.

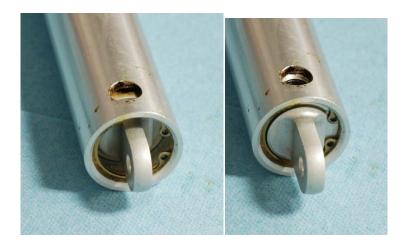
The closed end plug can be reinstalled. Align the threaded port with the hole in the cylinder and push the plug in far enough to reinstall the snap-ring. Finally, pull the plug back out up against the snap-ring.

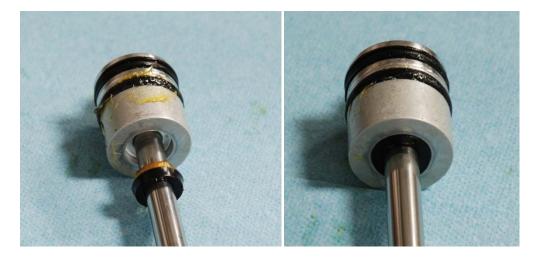
The rod end plug can now be slid onto the shaft such that the shaft seal bore is visible. The shaft seal is flared such that when confined to its nominal dimensions it exerts some pressure against the sealing surfaces of both the plug and the shaft. This makes it a little challenging to install. One option is to slide the lubricated seal onto the shaft and then use a tongue depressor or similar to work the lip of the seal into the plug cavity.

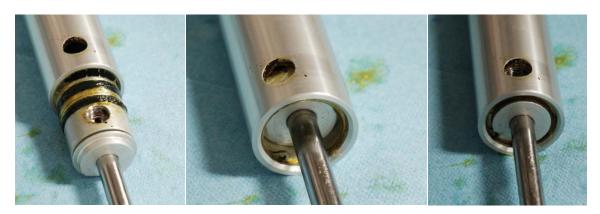
Slide the retaining plate onto the shaft and with a generous quantity of O-Lube work the assembly into the cylinder. Again, align the fitting port and the hole in the cylinder wall, but push the assembly in far enough to install the snap ring. Finally, pull the piston assembly and plug back up against the snap ring.

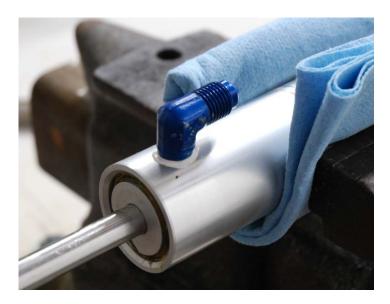
The last step is to reinstall the AN fittings. Loctite 565 work very well. It is an anaerobic thread sealer so excess sealant on the exterior will not cure and should be wiped off.

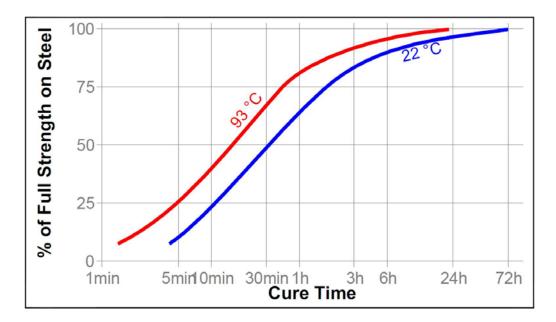
It is preferable to let the Loctite cure 24 hours before use, although it can be put back into service sooner in a pinch. After just 1 hour more than half of its strength has been obtained.
